**300 Series**  
**Normally Closed, Electric Sleeve Valve**  
**Troubleshooting Guide**

The enclosed tables identify commonly observed field conditions specific to the 300 sleeve valve series. Each condition identifies possible root causes and troubleshooting tips.

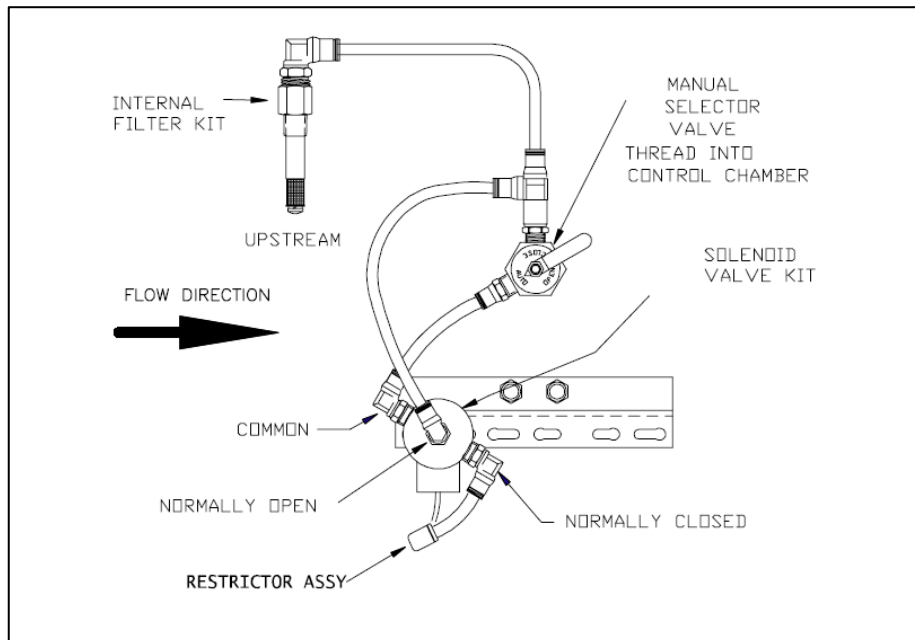
**External Tubing on 300 Series Valve**  
**Figure 3-1**

<p><b>The valve should <u>not</u> be pressurized during servicing.</b></p> </div>	<p>Turn the selector switch from the “Auto” position to “Open” and verify the valve opens fully. In this position the solenoid is bypassed completely.</p> <p>Locate the restrictor assembly as shown in figure 3-1. Remove the brass fitting from the end of this tube and remove any accumulated debris. This is a compression fitting and to release the tubing push the metal ring inward while pulling on the external tubing at the same time. See Figure 3-2. Next remove the 90° fitting at the end of the restrictor assembly that is threaded into the solenoid base. Verify it is also free of any debris.</p> <p>Using a multi-meter, disconnect the field wires to the solenoid. Set the multi-meter to “Ohms” and place the red and black probes on both wires leading into the solenoid. If Ohms resistance is higher than 65-85 ohms, then replace the solenoid.</p>

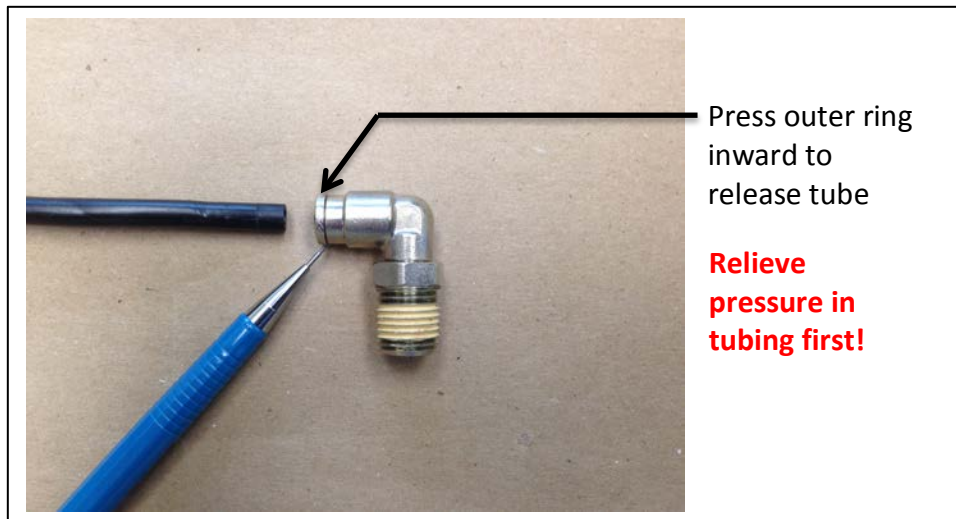
**Releasing a Compression Fitting**  
**Figure 3-2**

<p><b>The valve should <u>not</u> be pressurized during servicing.</b></p> </div>	<p>The “selector switch” should be set to the “Auto” position, see Figure 3-2.</p> <p>Visually inspect on all external tubing. Replace or re-install any broken or displaced tubing. Replacement tubing can be ordered from Underhill International or through your local distributor. The fittings are compression-fit type and are pushed inward to release tubing. See Figure 7-1.</p>

Observed Field Condition	Possible Cause	Troubleshoot Tips
The valve is closing very slowly compared to adjacent valves.	The tubing between the selector switch and the base of the solenoid is clogged.	<p>Set the selector switch to the “Closed” position (see Figure 3-2). Locate the external tube between the selector switch and the base of the solenoid. See Figure 5-1.</p> <p>Disconnect the tubing at the base of the solenoid and confirm water flows freely. It may be necessary to relieve any residual pressure downstream of where the mainline has been turned off. <u>A pressurized line will make removing the external tubing difficult.</u></p> <p>A low volume of water indicates the filter is clogged. Re-connect the tubing to the corresponding compression fitting to stop the flow of water. Go to the next step to see how to locate and clean the filter.</p>

<b>The valve should <u>not</u> be pressurized during servicing.</b></p>	<p>Locate the filter inlet on the side of the valve body see Figure 3-2. This may require some removal of gravel in the bottom of the valve box to access this component.</p> <p>De-pressurize the mainline by closing a gate valve(s) prior to starting this task. Move the selector switch from “Auto” to “Open” to relieve any pressure within the valve after the mainline pressure has been relieved.</p> <p>Disconnect the external tube into the “Tee” compression fitting and verify if water flows freely.</p> <p>Using a small wrench loosen the larger of the two nuts and remove the entire filter assembly from the valve. See Figure 7-1.</p> <p><u>Note the 90° elbow is a swivel and can be rotated independently from the filter body.</u></p> <p>Locate a small hexagonal nut on the end of the filter assembly and remove with a 3/8” wrench. Carefully twist the fine stainless steel mesh screen and slide off the end of the brass holder, see Figure 7-1. Clean both the screen and the internal brass fitting making sure the port is completely clean.</p> <p>Re-assemble the filter assembly and external tubing in the reverse order, then pressurize the system and actuate the valve electrically to confirm operation.</p>

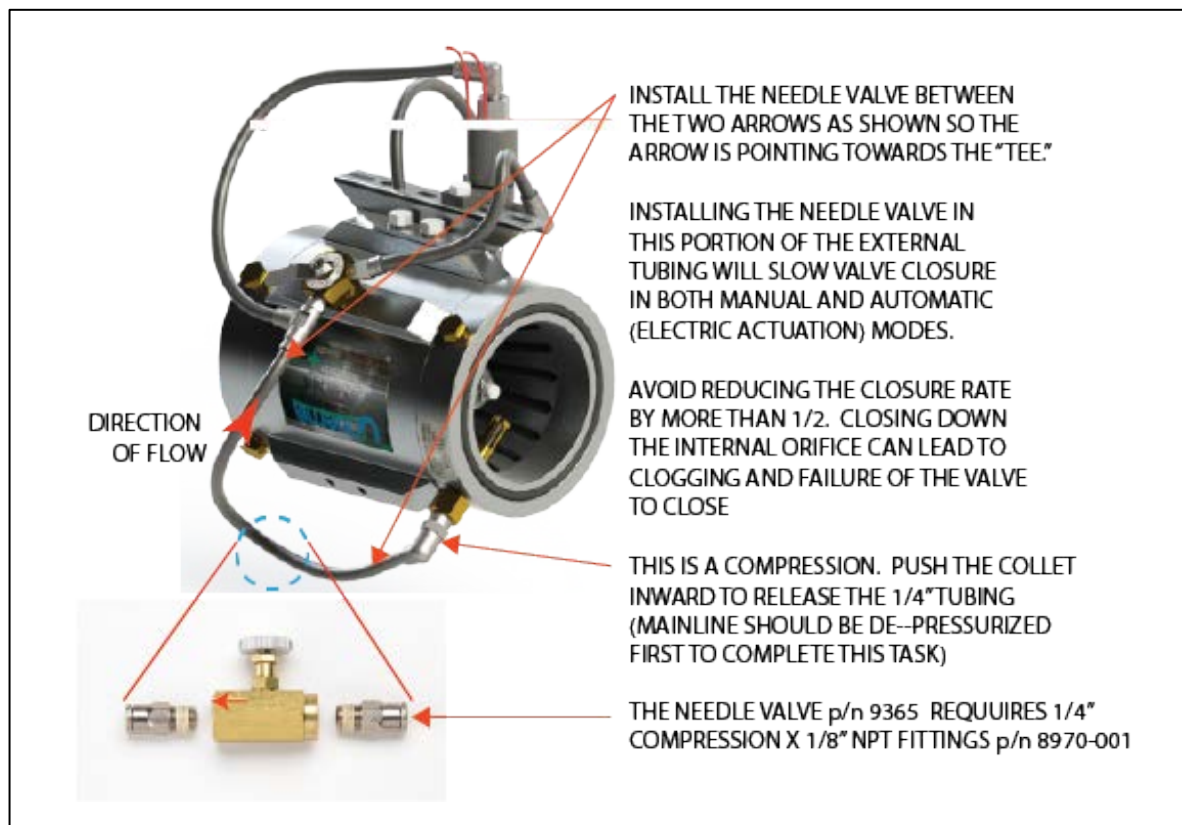
**Needle Valve Instructions**  
**Figure 9-1**

Observed Field Condition	Possible Cause	Troubleshooting Tips
The valve is closing too fast and “water-hammer” can be felt in the piping system during valve closure.	The valve is closing too fast and valve closure needs to be slowed down.	A “needle-valve” can be ordered as a separate part from Underhill. It is installed in-line within the external tubing as shown in Figure 9-1. Once installed it can be adjusted to slow down valve closure by turning the knob in a clockwise or counter-clockwise manner to set a closure rate that prevents water hammer.
